Technical Service Bulletin

NUMBER: 14-002-01 GROUP: Fuel DATE: Mar. 16, 2001

Longer Than Normal Engine Crank Time Prior To Engine Start

1999 - 2001 (WJ) Grand Cherokee 2001 (WG) Grand Cherokee

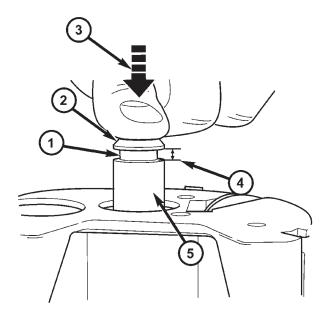
FIGURE 2 - MEASURING GLAND WIDTH

- 9. An ALTERNATE METHOD to determine whether a spacer is required is to measure the width of the sealing ring gland (Figure 2).
 - a. Apply sufficient pressure to hold the poppet firmly in place on top of the fuel outlet port. To prevent an incorrect measurement, the applied pressure must be on-center. The poppet can easily tip up if an off-center force is applied to it.
 - b. Carefully measure the width of the sealing ring gland.
 - c. If the gland width is between 3.0 and 3.5 mm (0.118 to 0.138 in.), then a spacer is not required to be installed.
 - d. If the gland width is 4.0 mm (0.157 in.) or greater, then a spacer is required to be installed prior to the installation of the new sealing ring. The sealing ring spacer is 1 mm (0.394 in.) in thickness and is used to prevent excessive movement (wear) of the sealing ring in the gland.

- 7. If the module part label indicates that the fuel module assembly was built on or before November 04, 1999 (Julian date of 99308), then a spacer must be used with the sealing ring. The split washer in the repair kit is used as the sealing ring spacer.
- NOTE: FAILURE TO USE THE SPLIT WASHER, AS A SPACER FOR THE SEALING RING (WHEN REQUIRED), MAY CAUSE EXCESSIVE MOVEMENT AND DAMAGE TO THE SEALING RING.

8. If the module part label indicates that the fuel module assembly was built after November 04, 1999 (Julian date of 99308), then a spacer must NOT be used with the sealing ring. The split washer in the repair kit can be discarded.
