NUMBER: 08-014-04

Radio Intermittent Audio

This bulletin involves applying a label over slots in the radio top cover.

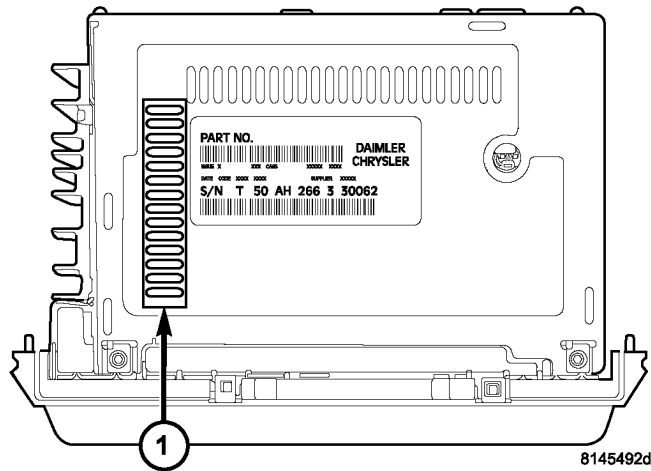
Fig. 1 COVER SLOTS

Audio drops out when vehicle is moved from cold to warm or humid environment. Condensation builds up across the audio amplifier circuitry causing amplifier to shut down. Typically, cycling ignition switch Off and back On will restore the audio output.

1. Remove radio from Instrument panel. Wiring connectors can remain connected.
2. Place 3M Vinyl Plastic Electrical Tape Super 33+ or Equivalent over the row of slots on the left hand side of the radio top cover, be sure to not cover information (barcode, etc.) on the radio's primary label (Fig. 1). Be sure the slots are covered completely and the tape is sealed all around the edges. Also cover and seal with tape, the two slots between the heat sink and the row of covered slots.

1 - COVER SLOTS COMPLETELY

NOTE: The two slots between the heat sink and the row of covered slots (1) also need to be completely covered and sealed with tape.
