Technical Service Bulletin

NUMBER: 21-011-01

NV247 Transfer Case Seepage

1999 - 2000 WJ Grand Cherokee

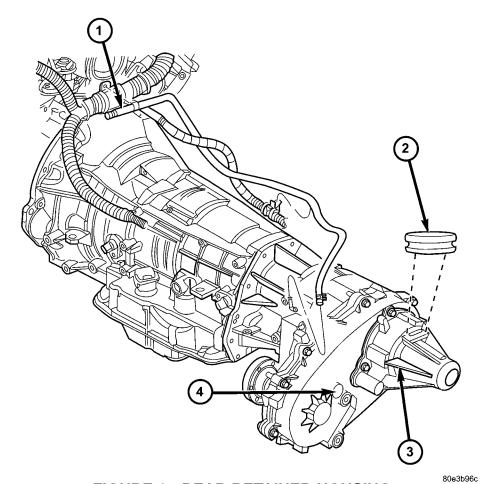
FIGURE 1 - REAR RETAINER HOUSING

Fluid seepage under the vehicle transmission/transfer case area.

- 4. The vent hose is located above the transmission housing near the back of the engine. It is trapped under the dipstick tube mounting bracket. From below, pull the hose out from under the bracket and down to a workable area on the passenger side of the transfer case (Figure 1).
- 5. Cut off the end of the hose just below the vent cap housing and remove the band clamp from the cut end of the hose.
- 6. Insert the new Jiggle Cap vent (PN J5352955) into the end of the hose.
- 7. Re-aline the vent hose with the dipstick tube housing and tie wrap it to the dipstick tube just below the dipstick tube mounting bracket.

- 11. Remove the propeller shaft.
- 12. Remove the four rear retainer housing mounting bolts.
- 13. Remove the rubber snap ring access plug on the top side of the rear retainer housing (Figure 1).

- 14. Using an appropriate tool, spread the rear bearing locating snap ring and remove the rear retainer housing.
- 15. Clean the mating surfaces of the rear retainer housing and the transfer case and apply new Mopar RTV Sealant (PN 04883971).

- 16. Spread the rear bearing locating snap ring and install the rear retainer housing on to the transfer case.
- 17. Torque the four rear retainer housing bolts to 33.9 Nm (25 ft. lbs.)

- 18. Using the alignment marks previously made, install the propeller shaft, torquing the bolts to 18.9 Nm (14 ft. lbs.)
- 19. Using NV247 Transfer Case Fluid (PN 05016796), check and refill the transfer case to the proper level (fluid should be able to be touched by a fingertip inserted into the fill hole on the transfer case.)(Figure 1).

- 20. Install the new rubber rear retainer snap ring access plug (PN 05018919AA.)
- 21. Lower the vehicle and close the hood.
