Technical Service Bulletin

NUMBER: 21-03-00

DATE: March 10, 2000

NV-242 And NV-242HD Transfer Case Oil Seepage From The Sector Shaft Oil Seal

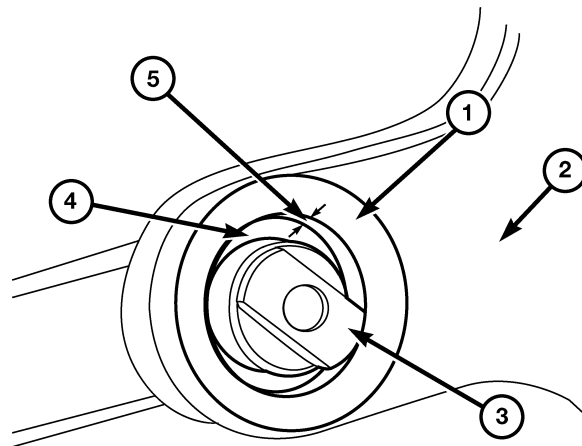
FIGURE 1

The customer may complain of a red-in-color oil seepage from under the vehicle. The oil seepage may be localized to the sector shaft seal of the transfer case.

1. Raise and support the vehicle. Remove the transfer case from the vehicle. Remove the sector shaft and seal from the front case of the transfer case. Refer to the appropriate Service Manual, Section 21: Transmission and Transfer Case for removal, disassembly, assembly and installation instructions.
2. Using a suitable bearing driver, carefully recess the sector shaft bearing to a depth of 7.6 – 8.1 mm (0.300 - 0.320 inches). The distance is measured from the top edge / surface of the sector shaft bore to the top of the sector shaft bearing. Figure 1.

NOTE: DO NOT RECESS THE BEARING TOO FAR OR CONTACT BETWEEN THE BOTTOM OF THE SECTOR SHAFT BEARING AND THE SECTOR SHAFT WILL OCCUR.

4. Install the new sector shaft (p/n 05014047AA) and sector shaft seal (p/n 05014046AA). Make sure that the sector shaft seal is flush with the case.
5. Using the appropriate Service Manual procedures, assemble the transfer case and install both the transfer case and the rear propeller shaft.
6. Install transfer case fluid (p/n 05010124AA). Fill the transfer case to the correct level.
7. Lower the vehicle.
