NUMBER: 23-009-04

Popping Or Clicking-Like Sound In Area Of Front Seat Frame

1999 - 2004 (WJ/WG) Grand Cherokee

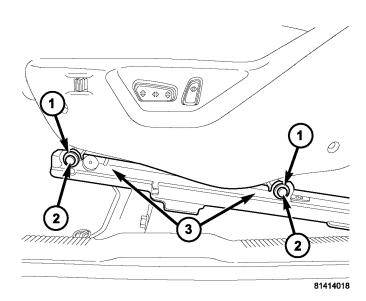
Fig. 1 OUTBOARD SEAT TRACK PIVOTS

The customer may experience a popping or clicking-like sound coming from the area of either front seat frame. The sound may be more frequent during changes in vehicle acceleration (i.e. braking, accelerating, or turning).

- 1. Using the power seat controls, raise the seat cushion section of the seat to its highest position so that the front and rear pivot shafts are exposed. (Fig. 1)
- 2. Apply lubricant between the backside of each spring washer and the seat frame rail. It is important to force lubricant between the contacting surfaces. Lubricate the spring washers at each corner of the seat frame (four in total) (Fig. 2).
- 3. While lubricating each spring washer contact surface, apply lubricant between the pivot shaft and seat frame rail contact surfaces.
- 4. Cycle (raise and lower, adjust forward and rearward) the seat cushion portion of the seat to distribute the lubricant.
- 5. Repeat steps 1 to 4 to ensure complete lubrication.
- 6. Repeat this procedure for the other front seat.
- 7. Remove any excess lubricant.
