Technical Service Bulletin

NUMBER: 23-038-00

Seat Belt Turning Loop Cover Repair

1999 - 2000	WJ	Grand Cherokee
1999 - 2000	LH	Concorde, Intrepid, LHS, 300M

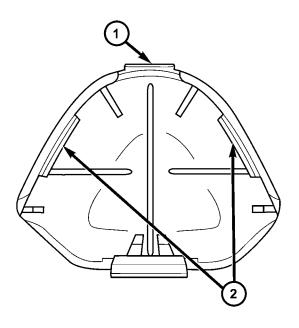
80c64870

The cover on the seat belt turning loop may break at the plastic hinge. A Repair Procedure has been developed to replace the cover rather that replacing the seat belt assembly.

1. Remove the cover from the base of the appropriate part listed above and file the hinge flush with the cover(Fig. 1).

Apply a coating of adhesive promoter such as 3M p/n 06396 or equivalent, to the inside of the cover in the two areas where the foam tape will be applied, and to the turning loop(Fig. 1).

- 1 Hinge
- 2 Foam Tape
- 3. Cut four 3/4 inch pieces of double side adhesive foam emblem tape, such as 3M p/n 06382 or equivalent. Remove the protective film and apply two pieces of tape to each side of the cover as shown(Fig. 1).
- 4. Install the cover on to the turning loop by rolling it on from the top and snapping the retainer into the slot.
