# Technical Service Bulletin

**NUMBER:** 23-10-00

Window Regulator Sticks At Top of Travel

1999 - 2000 (WJ) Grand Cherokee

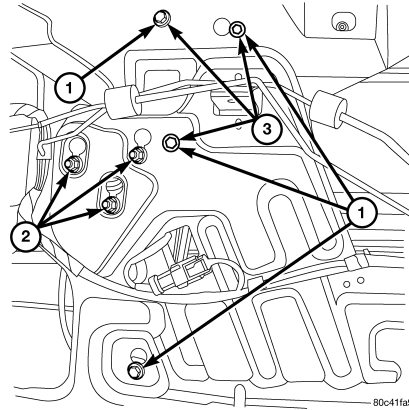
**FIGURE 1**

A front window may be inoperative, stuck in the up position.

**1 - REGULATOR BOLTS**  
**2 - WINDOW MOTOR NUTS**  
**3 - ELONGATE THESE HOLES**

1. Remove the door trim panel.
2. **\*\*Remove the window retaining clips to the lift plate.\*\***
3. **\*\*Separate the glass from the lift plate, slide it to the top of the travel and tape the glass to the doorframe.\*\***
4. **\*\*Remove the regulator attaching bolts (See Figure 1) and the three-window motor attaching bolts. \*\***
5. **\*\*Disconnect the wire harness from the regulator.\*\***
6. **\*\*Remove the window regulator \*\*.**

- 7. Mark the centerline of the top three regulator holes at the top. Measure 5 mm (3/16 in.) straight up from the top of the hole and make another mark at that location.

- 8. Using an 8 mm (5/16 in.) grinding stone or a rat tailed file, elongate the holes upward to the marks made earlier at the three bolt locations. This will allow the regulator to be moved upward 5 mm (1/4 IN.).
- 9. Coat the holes with a corrosion resistant primer and allow the primer to dry.
- 10. **\*\***Install the new regulator and attaching bolts applying upward pressure to assure that the regulator seats in the higher location. Tighten the bolts to 9 Nm (80 in. lbs.).  
\*\*
- 11. Install the glass on to the lift plate and install the retaining clips.
- 12. Install the door trim panel.
