Technical Service Bulletin

NUMBER: 24-01-00

Improved Driver Side Floor Duct

1999 - 2000 (WJ) Grand Cherokee

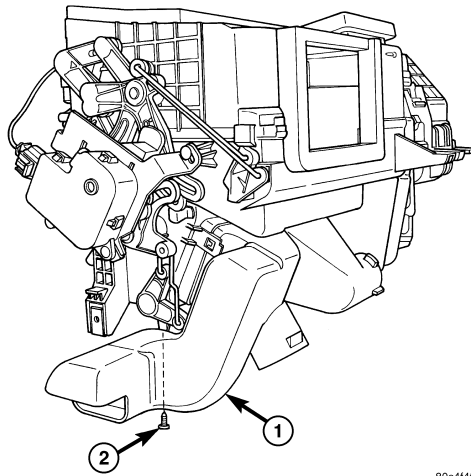
FIGURE 1

Customers may complain of cold driver's feet or inadequate airflow to the driver's side floor.

1. Locate the driver's side floor duct and attaching screw (See figure 1).
2. Remove the attaching screw and duct. This requires a very short #1 Phillips screw driver, approx. 1 1/2 inches in length.
3. Install the new duct, p/n 05012723AB, and install the attaching screw.
